Manhole Inspection Summary

Manhole # S53G__003MH

Insp Date: **4/14/08 3:43 PM**

Location Address: **3201 east pratt st**

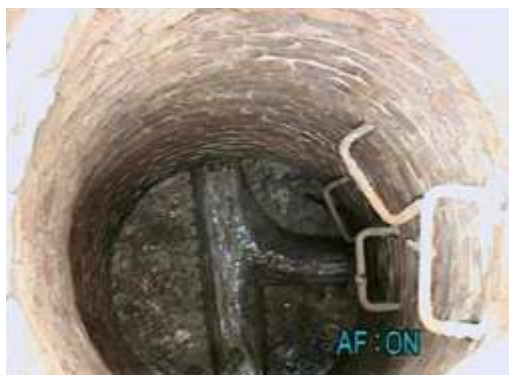
Defect 1

Condition: ☐ Sound ☐ Cracked ☐ Root Intrusion ☒ **Loose Brick** ☐ Deteriorated

Steps Count: **6** Missing: **0** ☒ **Corroded**

Corroded Steps, Loose Bricks in Chimney

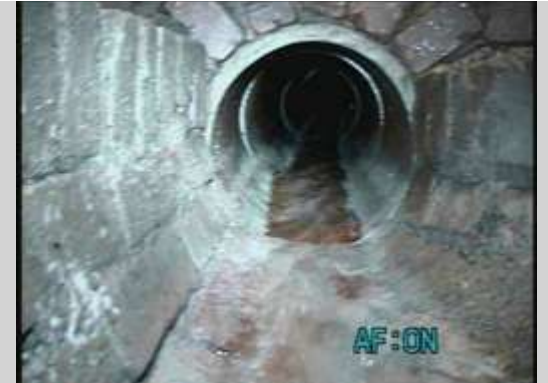
12 O'Clock Outflow

8 in. Circular Gravity Sewer
Pipe Out @ 12 O'Clock

Pipe Material: **Clay** ☐ Pipe Lined

Invert Depth: **10.00** (ft.) Flow Characteristics: **Fast**

Infiltration: **None** Pipe Seal Cond: **Unknown**

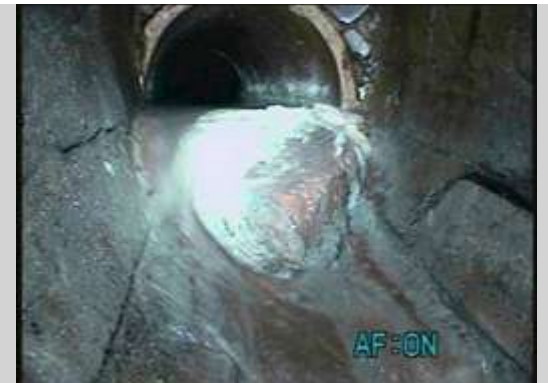
3 O'Clock Inflow

8 in. Circular Gravity Sewer
Pipe In @ 3 O'Clock

Pipe Material: **Clay** ☐ Pipe Lined

Invert Depth: **9.60** (ft.) Flow Characteristics: **Fast**

Infiltration: **None** Pipe Seal Cond: **Unknown**

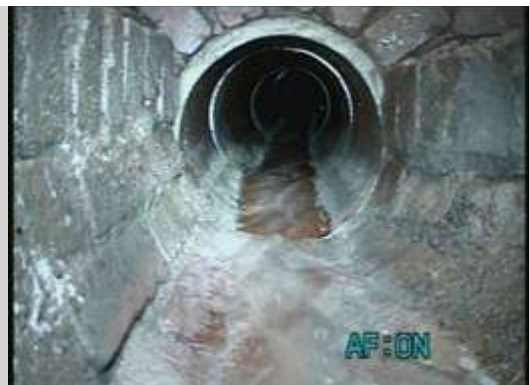
6 O'Clock Inflow

8 in. Circular Gravity Sewer
Pipe In @ 6 O'Clock

Pipe Material: **Clay** ☐ Pipe Lined

Invert Depth: **9.80** (ft.) Flow Characteristics: **Fast**

Infiltration: **None** Pipe Seal Cond: **Unknown**
